Tank AY-102 Leak Assessment

Dennis Washenfelder

November 7, 2012

Leak Assessment Conclusion

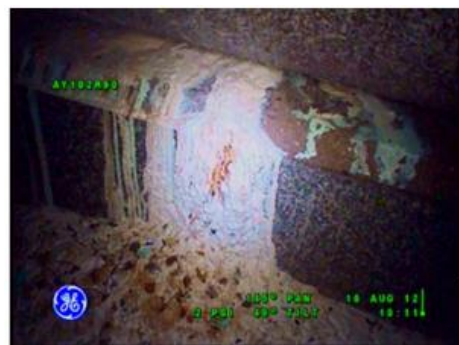
8/10/2012 Riser 90

The source of radioactive material discovered in the tank AY-102 annulus near Risers 83 and 90 is a leak from the primary tank.

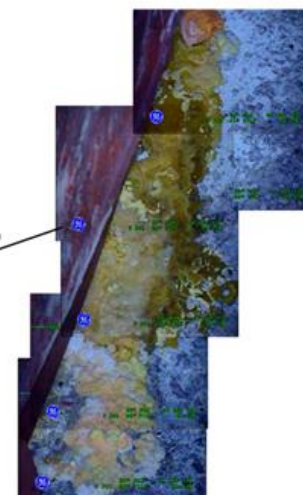
9/10/12 Riser 83

- Annulus Floor Material near Riser 83, September 26, 2012:
 - 45 mR/hr “Window Open”
 - Principal Chemical Constituents: NaNO_3 , Na_2CO_3 , NaNO_2 , KNO_3 ¹
 - Principal Radionuclide Constituents: Sr-90, 0.120 $\mu\text{Ci/gm}$; Cs-137, 90.9 $\mu\text{Ci/gm}$ (202 million disintegrations per minute per gram)
- Annulus Floor Material near Riser 90, August 10, 2012:
 - 800,000 dpm reading reported with detector near sample²

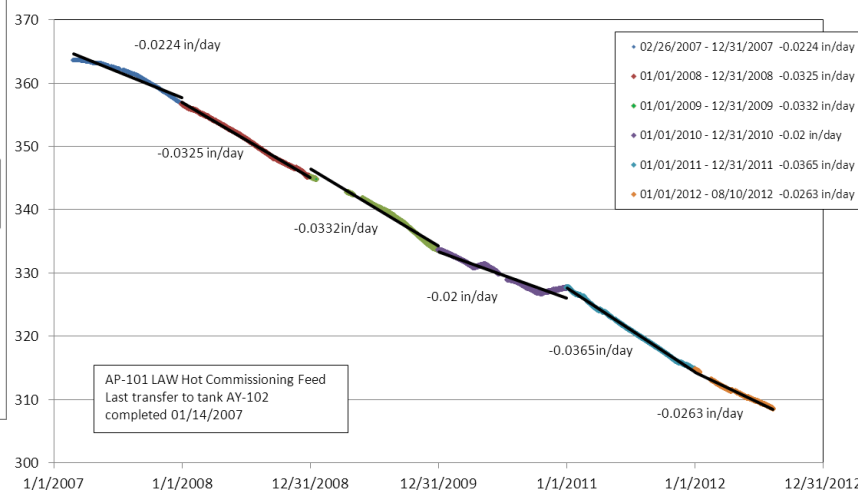
Tank AY-102 Liquid Level Decrease 2007-2012

- Tank C-106 sludge retrieval during 1998 – 1999 increased the tank heat load by ~ 94,000 BTU/hr
- Since AP-101 transfer in 2007, evaporation rate has averaged ~ 77 gal/day, or ~ 28,000 gal/year
- **A small, episodic leak could occur undetected inside the evaporation rate**

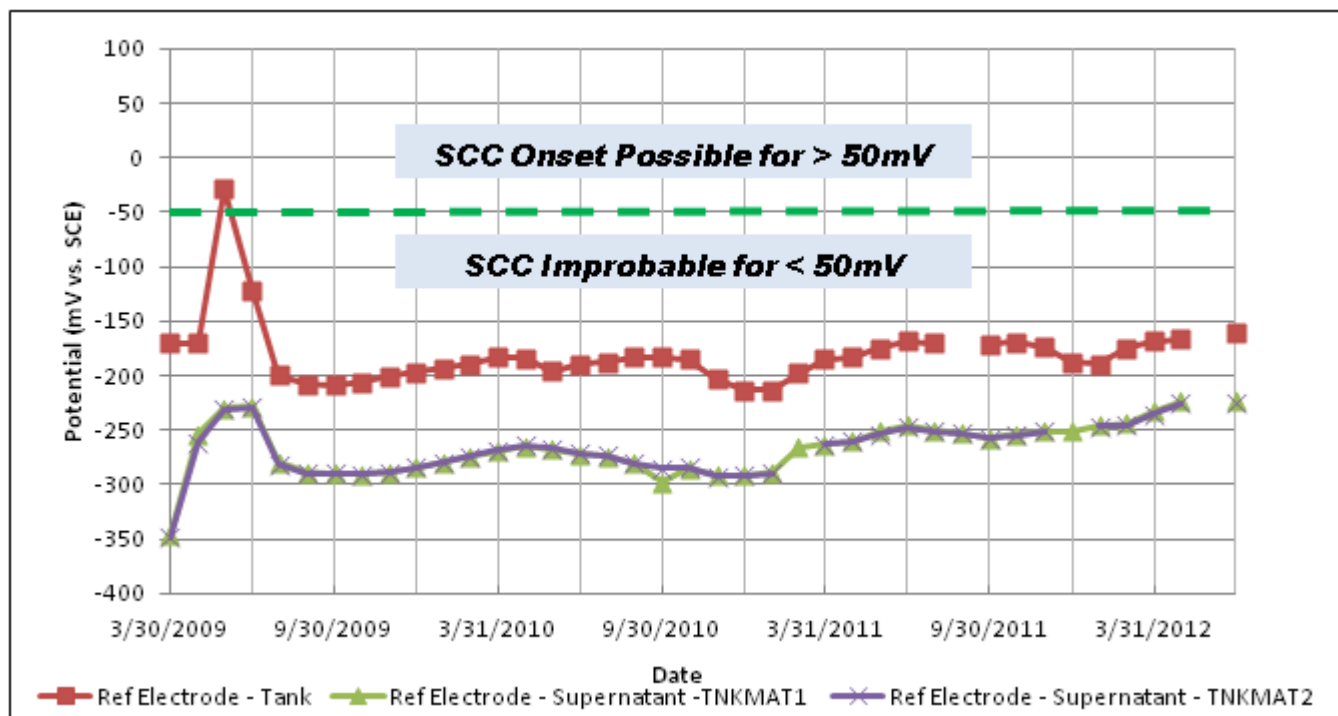
In-Tank Corrosion Probe

- Installed in March, 2009
- Electrodes located in supernatant and sludge layers and vapor space
- Sludge electrodes failed during corrosion probe installation. No readings are available.

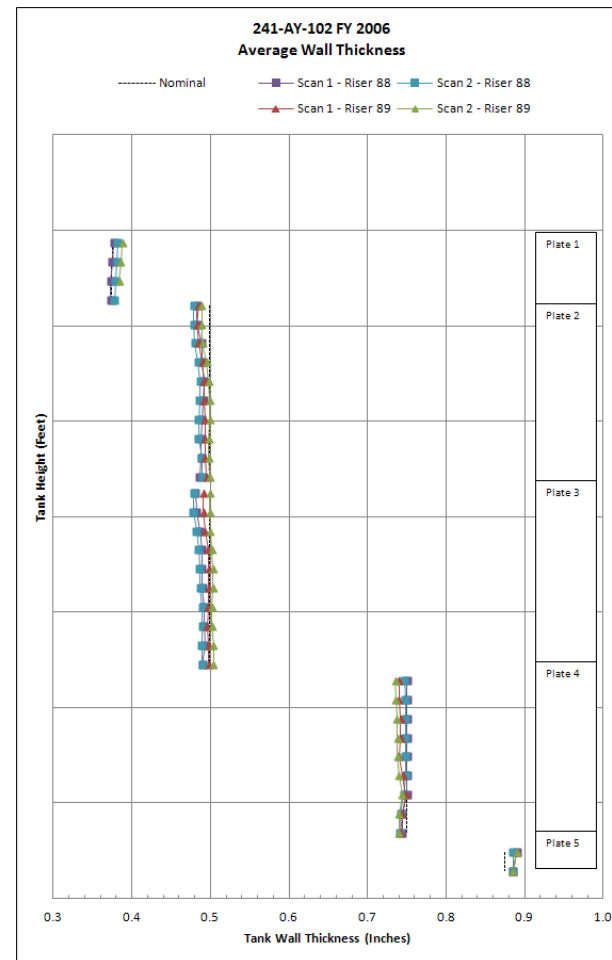
- In 2006 vertical scan pairs were completed in Risers 88 and 89 on surfaces
- **No significant primary tank wall loss has been detected by ultrasonic wall thickness scans**

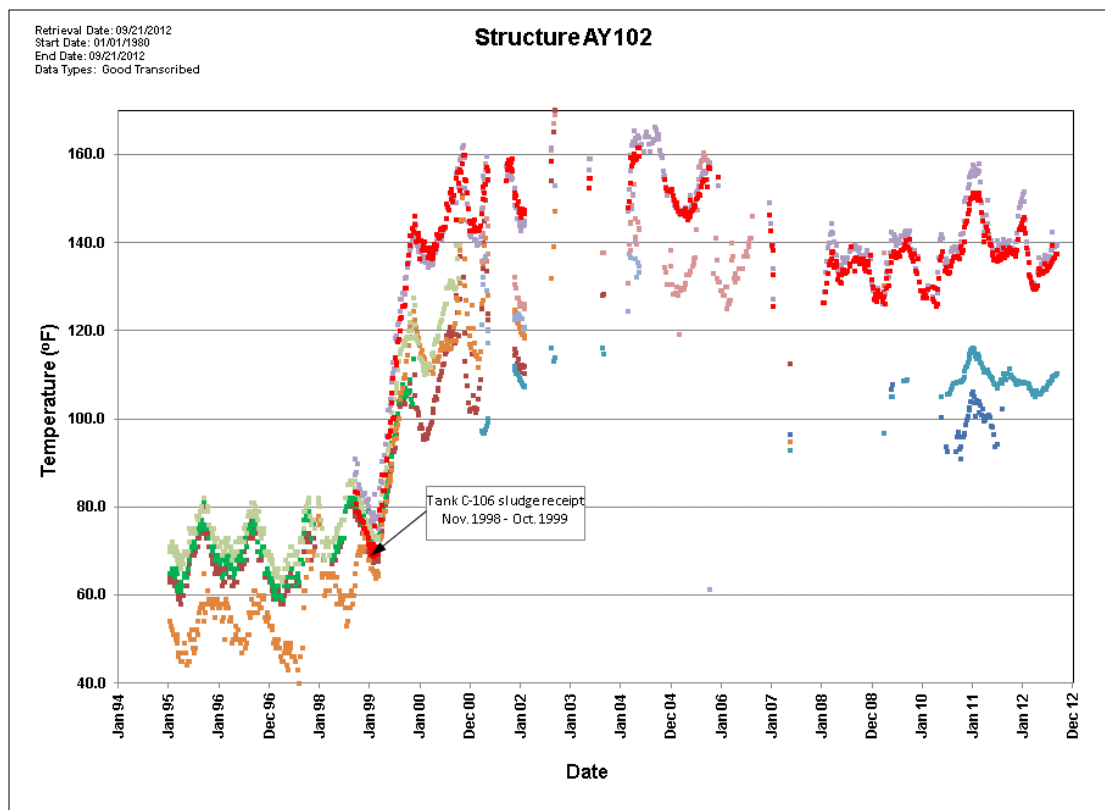
Waste Temperature

- Tank design and structural modeling temperature was 350°F; operating limit is 260°F
- From available records, highest waste temperature recorded is ~189°F in the sludge
- **Waste temperatures have been well within analyzed and allowable limits.**

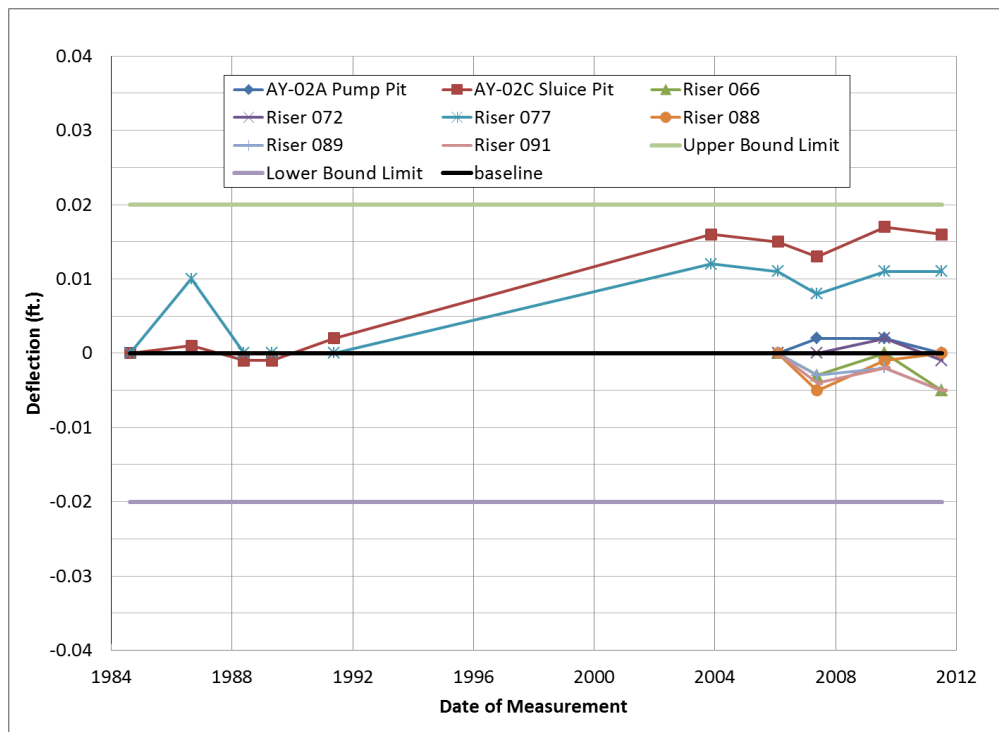
Tank Dome Deflection and Tank Settlement

- Eight benchmarks in use – two with data since 1984 and six new benchmarks first recorded in 2006
- Dome deflections up to 0.5-inches (~ 0.04-feet) are within load limits¹
- Survey data show a maximum dome deflection of < 0.02-feet since record keeping began
- **No evidence of dome deflection or tank settlement.**

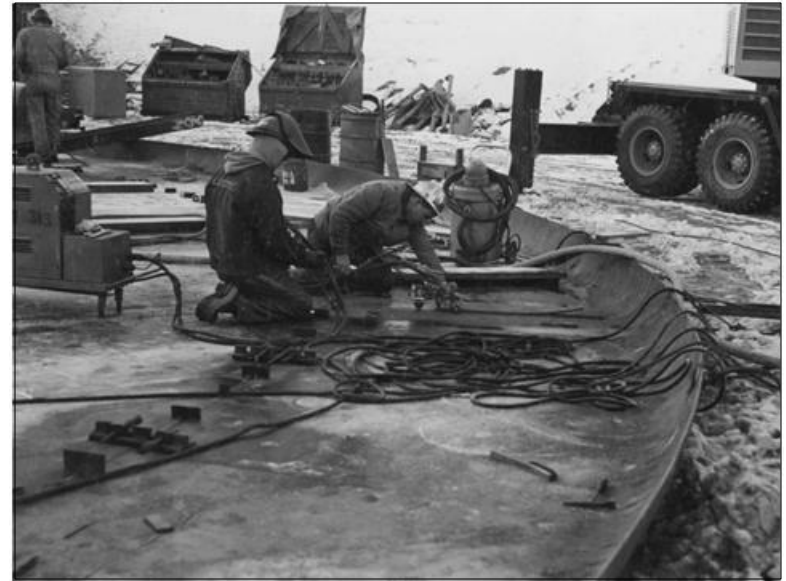
**Welding of Tank AY-102 Secondary Tank Bottom
(8051-1-Photo)**

- Use of thin ¼-inch plates complicated by work in extreme cold (-20°F to -10°F) caused liner warpage . As plates were preheated and welded, convex bulges and wrinkles appeared.
- Flame heating and water fast quench partially eliminated wrinkles. But when plates were heated by the sun new wrinkles appeared. These did not disappear as temperatures chilled.
- February, 1969 survey found 22 liner locations exceeding allowable 2-inch convexity. Root-to-crown slopes up to 1-inch per foot were present, exceeding allowable 3/8-inch per foot.
- These were eventually accepted for placement of the insulating refractory.

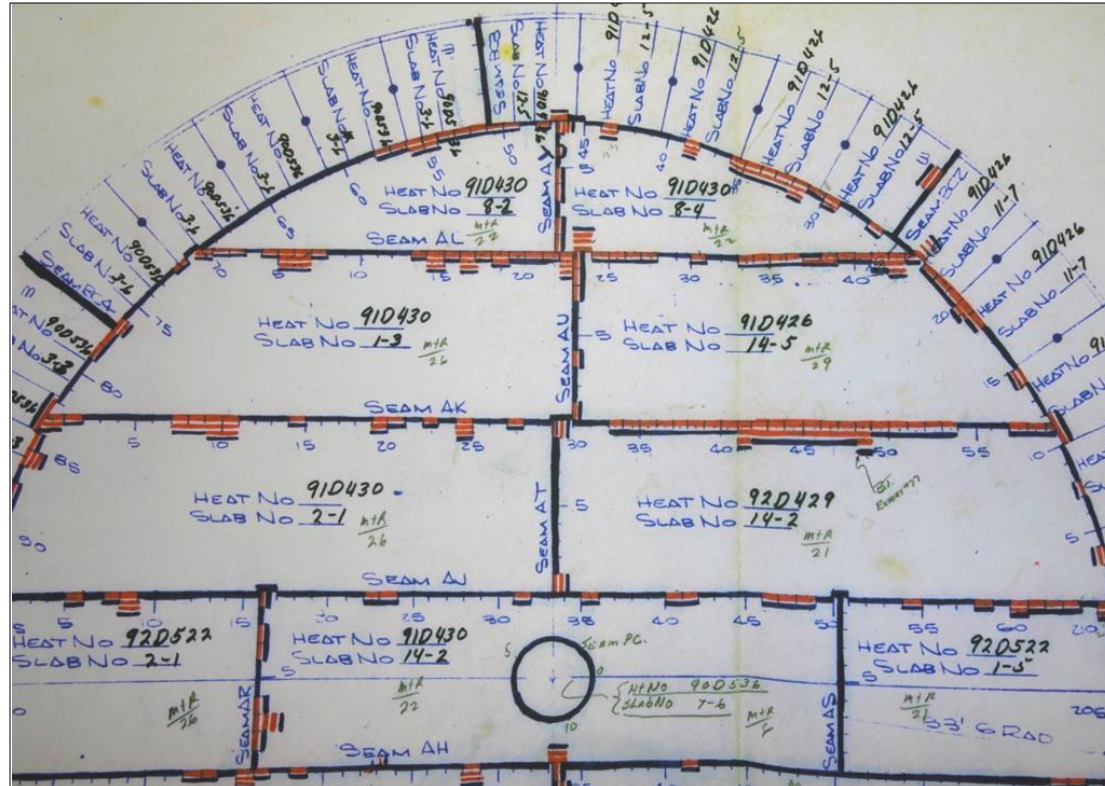
- Weld quality was a continuing concern. The floor plate weld rejection rate was ~ 36%.¹ Many welds were repaired several times before passing radiography.
- The radiography inspector accepted welds that were later rejected by the quality inspector.²

Primary Tank Bottom Plate Weld Map for northern section of tank showing rejected welds in red, and accepted welds in blue. The weld map shows instances of welds being repaired several times before passing inspection.

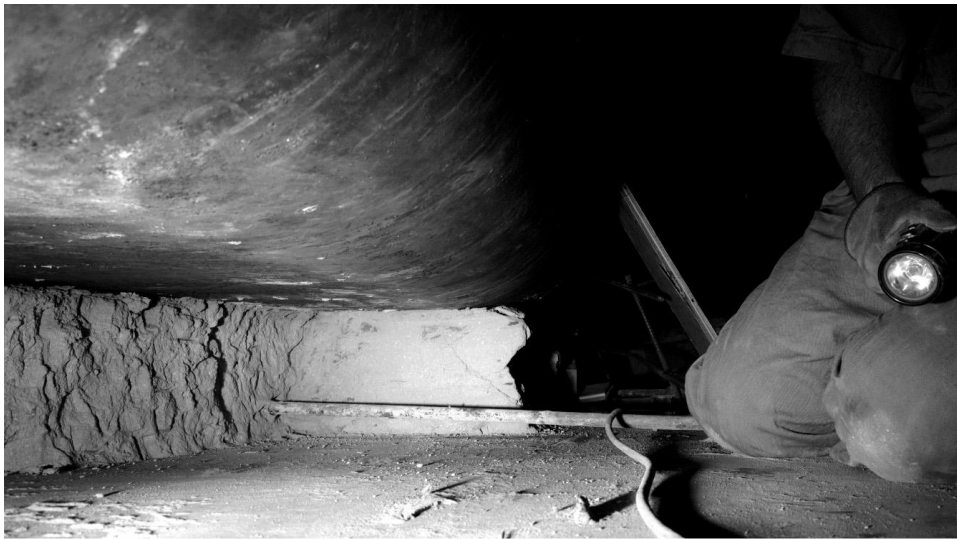
- ▶ Insulating refractory damage from stress-relief and hydrostatic test of primary tank
 - Full depth cracks ¼-inch wide extending several feet
 - Spongy top surface; affected depth increased as outer lip approached
 - Air passages blocked with spalled refractory
 - No evidence of tank settlement
 - Thought to result from skin friction as primary tank expanded and contracted across surface of refractory concrete pad during stress-relief, and “oil-canning” of the tank on the outside perimeter of the pad

Preparing Insulating Refractory for modification with use of reinforced concrete

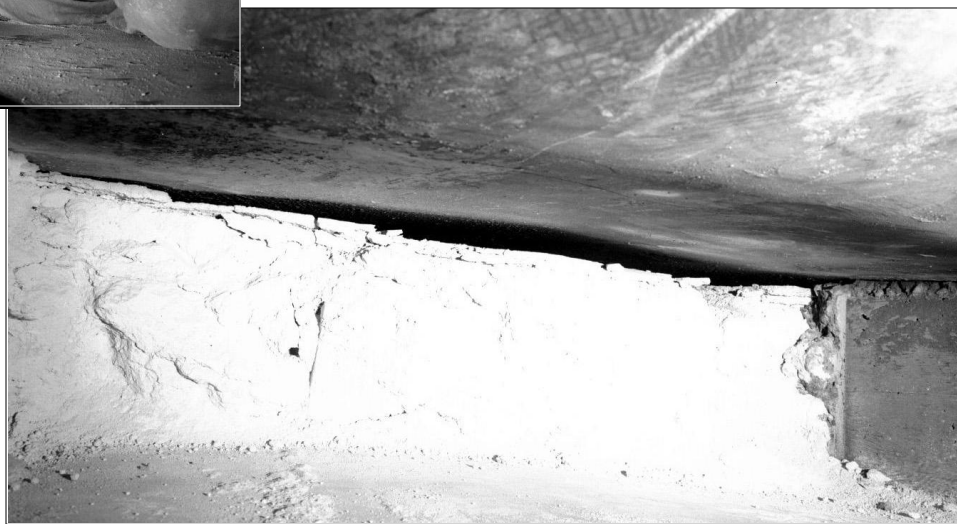
Tank AY-101 Primary Tank Gap over Insulating Refractory (52788-8-Photo). Gaps in Tank AY-102 were reported to be larger.
